**Asbestos-Containing Material
Three-Year Re-Inspection Assessment
Early Childhood Center
1200 South Children's Home Road
Sidney, Ohio 45365**

February 16, 2020

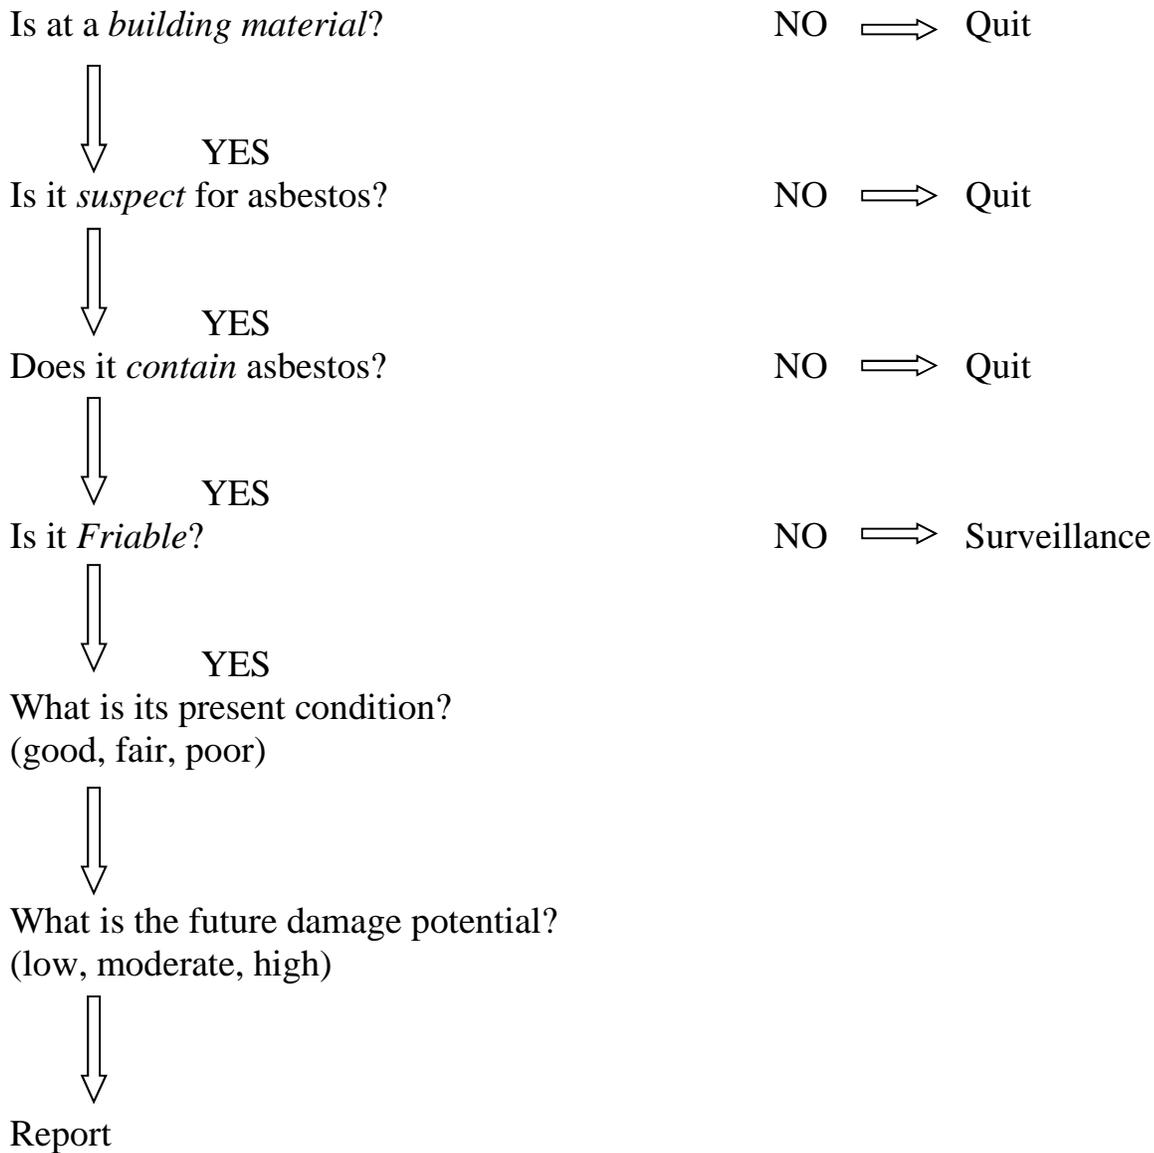
FIGURE 4-1. FLOW CHART FOR AHERA INSPECTION AND ASSESSMENT

Per AHERA, it is the responsibility of the field inspector to physically reassess any friable ACBM that is identified in the Management Plan (a material is friable if it can be reduced to powder by hand pressure, and is non-friable if it can't). This responsibility is outlined in the "Flow Chart for AHERA Inspection and Assessment", provided as Figure 4-1. In addition, the inspector is responsible for re-inspecting and touching any material identified in the Management Plan as non-friable ACBM to determine whether it has become friable and assessing such material if it has become friable.

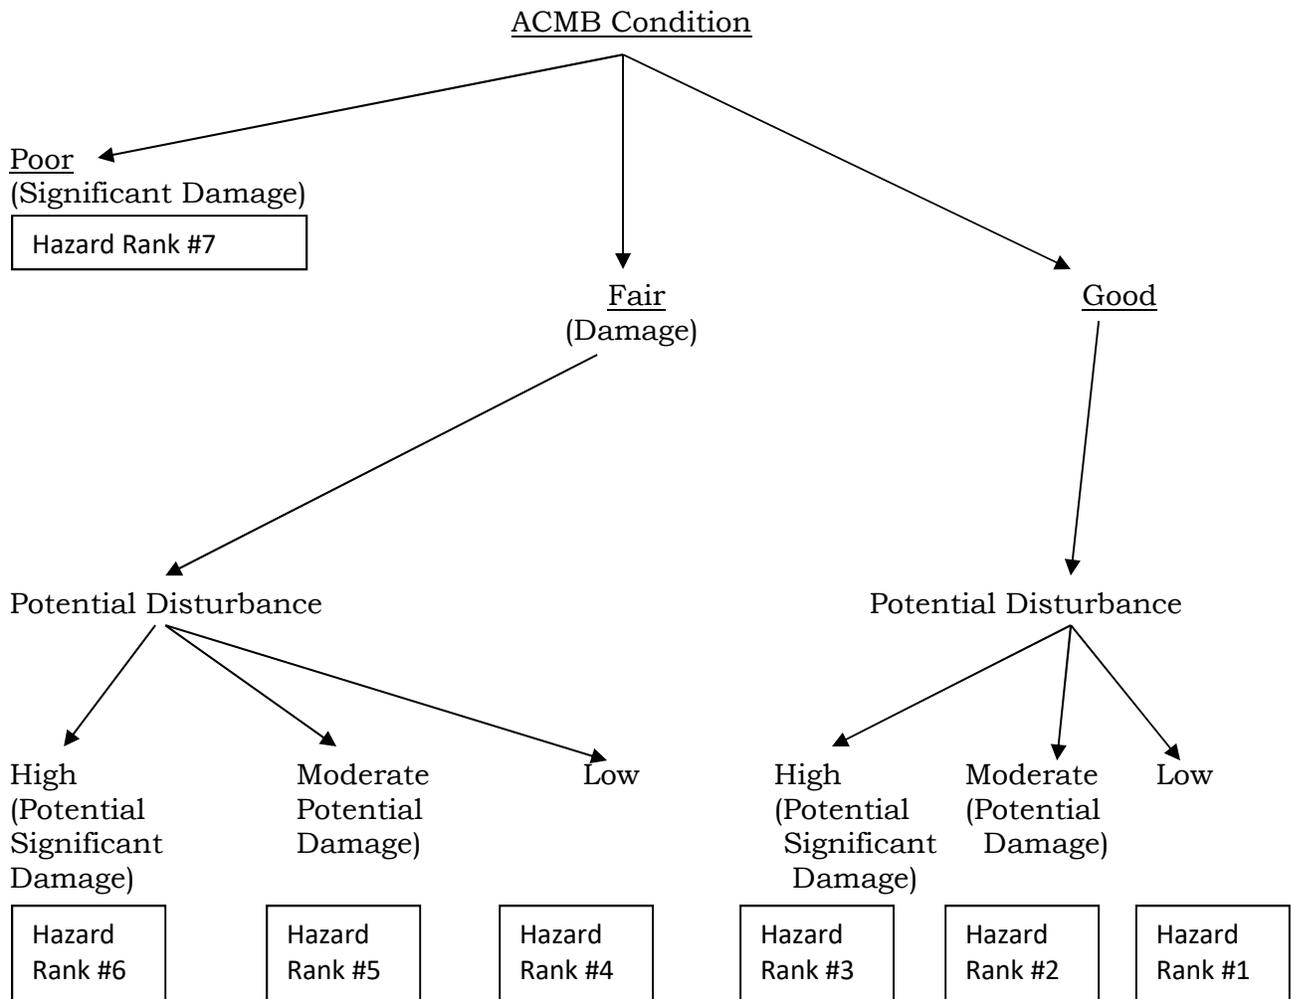
**EXHIBIT 6-1. CLASSIFICATION FOR HAZARD POTENTIAL
(DECISION TREE DISPLAY)**

The basis of the Hazard Assessment is the inspector's Physical Reassessment, and is derived by using the Decision Tree method as outlined in Exhibit 6-1. A brief description of the Decision Tree method is as follows:

- If the inspector has assessed the ACBM as Poor (significantly damaged), there is no sense in trying to estimate any potential for future damage; the material is in very bad shape now, and an appropriate response action must be performed as soon as possible.
- If the ACBM has been assessed as Fair (damaged), some estimate should be made of the potential for future damage; it is obvious that any ACBM that has a "potential for significant damage" should have a higher Hazard Assessment than ACBM with a "low" possibility of potential disturbance.
- The same logic that applies to ACBM assessed as Fair applies to ACBM that has been assessed as Good.

The above analysis will categorize the ACBM into one of the seven Hazard Ranks that are shown in the Decision Tree Exhibit. These Hazard Ranks are then converted into "Removal Priorities", and then into "Response Actions" as shown in Exhibit 6-2.
